Manhole Inspection Summary

Manhole # S45AA_009MH

Insp Date: **8/20/08 8:15 AM**

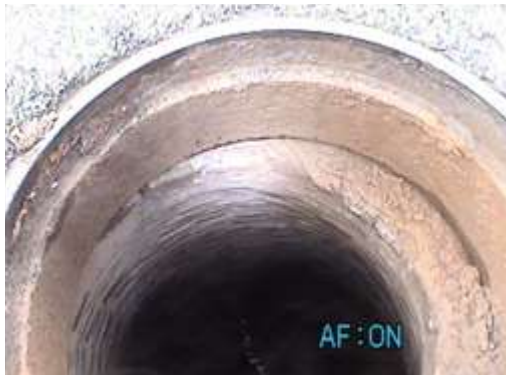
Defect 2

Infiltration: ☐ None ☐ Joint ☐ Cracks ☐ Mortar ☐ Roots ☒ **Wall**

Infiltration

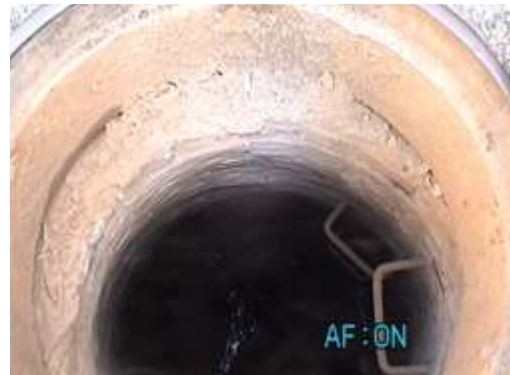
Defect 1

☒ **Leaks**

Frame leaks

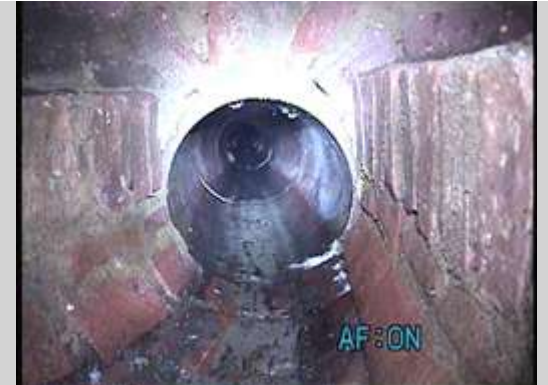
12 O'Clock Outflow

8 in. Circular Gravity Sewer
Pipe Out @ 12 O'Clock

Invert Depth: **10.75** (ft.) Flow Characteristics: **Slow**

Infiltration: **None** Pipe Seal Cond: **Sound**

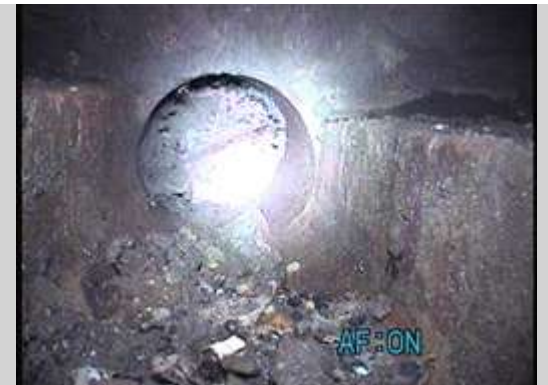
6 O'Clock Inflow

8 in. Circular Gravity Sewer
Pipe In @ 6 O'Clock

Invert Depth: **10.65** (ft.) Flow Characteristics: **None**

Infiltration: **None** Pipe Seal Cond: **Sound**

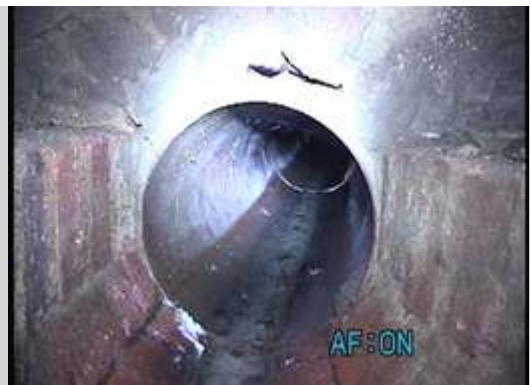
9 O'Clock Inflow

8 in. Circular Gravity Sewer

Pipe In @ 9 O'Clock

Invert Depth: **10.60** (ft.) Flow Characteristics: **Slow**

Infiltration: **None** Pipe Seal Cond: **Sound**
